Report Ref: 10010581
Test Facility: T2857
Test Vehicle: 12/04 Toyota Landcruiser Tray
VIN: JT731PJ7508534938
Engine No: 1HZ0176178
Reg No: WILLLS (Vic)

Design Check to ADR35/01 Commercial Vehicle Braking Systems

Performance test to VSB6 – ADR 35/091 Commercial Vehicle Braking Systems

Strength Test – Modified Toyota Landcruiser rear hubs and brake caliper mounting brackets

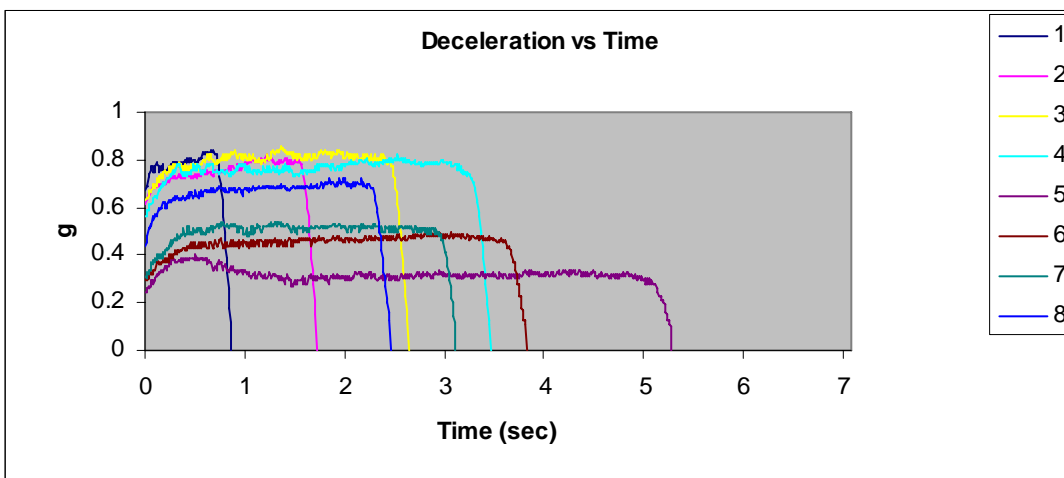
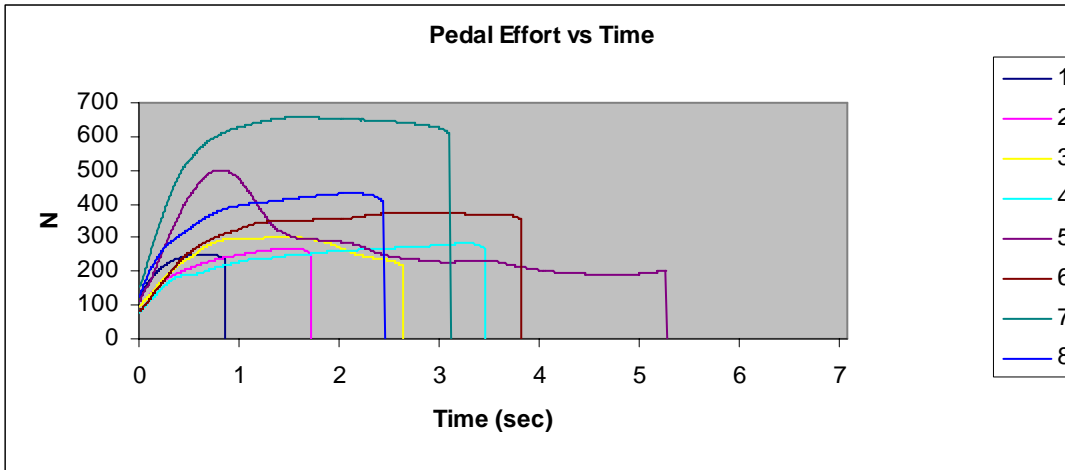
Performance Graphs – Laden Test

Test No	1	2	3	4	5	6	7	8
						Laden partial failure		
Mode	Service brake laden	Service brake laden	Service brake laden	Service brake laden	Front	Rear	Power assist	Load sensing proportioning valve
Aveg:	0.74 g	0.73 g	0.78 g	0.74 g	0.32 g	0.44 g	0.49 g	0.65 g
Maxg:	0.84 g	0.82 g	0.86 g	0.82 g	0.40 g	0.50 g	0.54 g	0.72 g
Max Pedal Effort: N	251.0	265.1	305.2	283.1	501.0	376.5	657.7	431.7
dT: sec	0.85	1.70	2.61	3.43	5.22	3.78	3.08	2.43
dV: kph	22.2	44.0	71.6	90.1	58.1	59.2	53.3	55.6
dS: m	2.6	10.4	25.9	42.9	42.1	31.1	22.8	18.8
Brake Delay: sec	0.07	0.07	0.07	0.07	0.07	0.07	0.07	0.08
MFDD: m/s ²	7.56	7.37	7.91	7.47	3.04	4.51	5.05	6.65

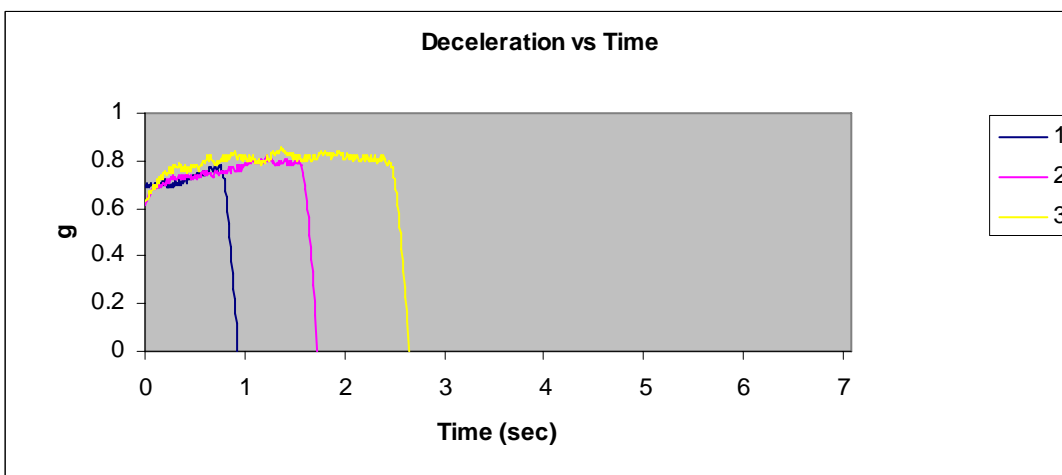
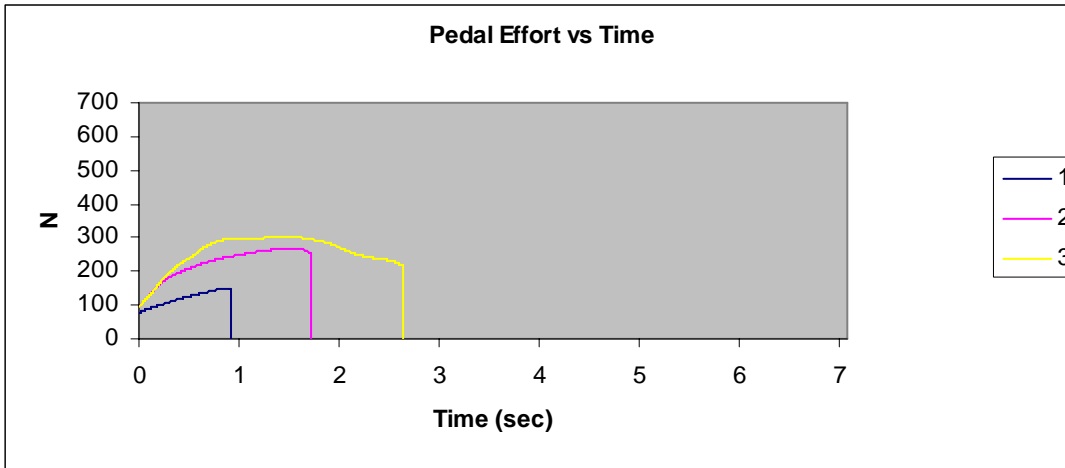
Performance Graphs – Unladen Test

Test No	1	2	3
Aveg:	0.68	0.77	0.80
Maxg:	0.78	0.90	0.92
Max Pedal Effort: N	251.0	149.6	190.8
dT: sec	0.91	1.63	3.40
dV: kph	21.9	44.4	96.5
dS: m	2.8	10.1	45.5
Brake Delay: sec	0.07	0.08	0.07
MFDD: m/s ²	6.92	7.84	8.13

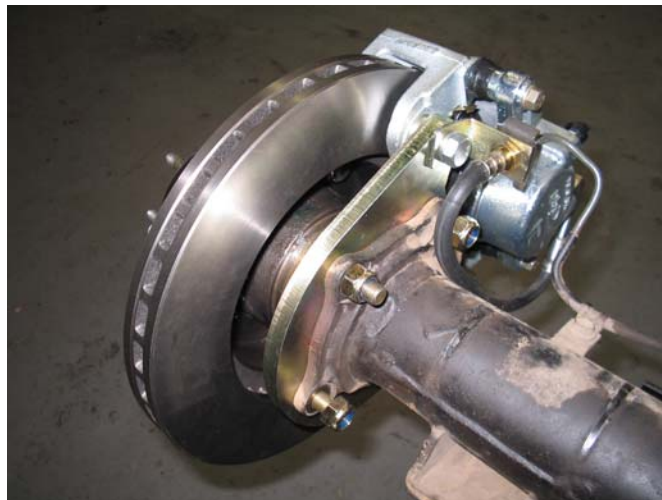
It was agreed with the client that a static test procedure be used to confirm the strength of the modified rear hub, caliper mounting brackets and associated components. A rear axle and differential housing sourced from a Toyota Landcruiser was fitted with a complete modified rear hub and replacement service brake assembly as shown:

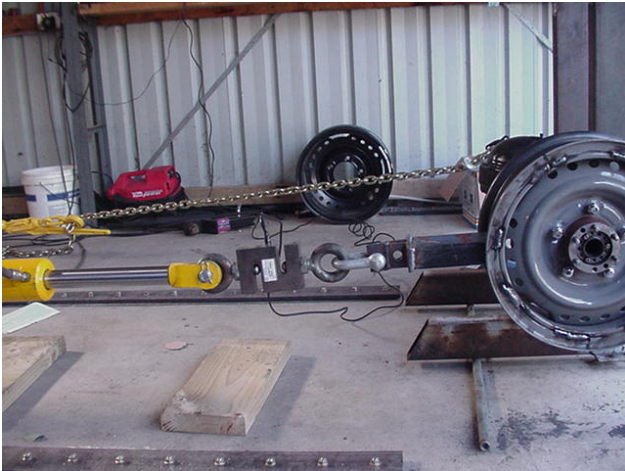
Test rig simulating 4g vertical load

Test Mode	Target load	Applied load	Comments
4g vertical bump	5000 kg	5196 kg	Applied load exceeds target load. No cracking, separation, distortion or other failure observed.
1g vertical and +0.6g lateral rut load	1250 kg vertical 750 kg lateral rut	1386 kg vertical 894.6 kg lateral rut	Applied load exceeds target load. No cracking, separation, distortion or other failure observed.
1g vertical and -0.6g lateral rut load	1250 kg vertical 750 kg lateral rut	1770 vertical 856.1 kg lateral rut	Applied load exceeds target load. No cracking, separation, distortion or other failure observed.
2g vertical and 2.5g overturning load	2500 kg vertical 5363 kg overturning	1814 kg vertical 2769 kg overturning	Failure of the wheel rim occurred before full test load applied. Examination of brake and hub components revealed no evidence of cracking, separation, distortion or other failure.
2g vertical and 1.2g braking	2500 kg vertical 1500 kg braking	2870 kg vertical 1704.6 kg braking	Applied load exceeds target load. No cracking, separation, distortion or other failure observed.

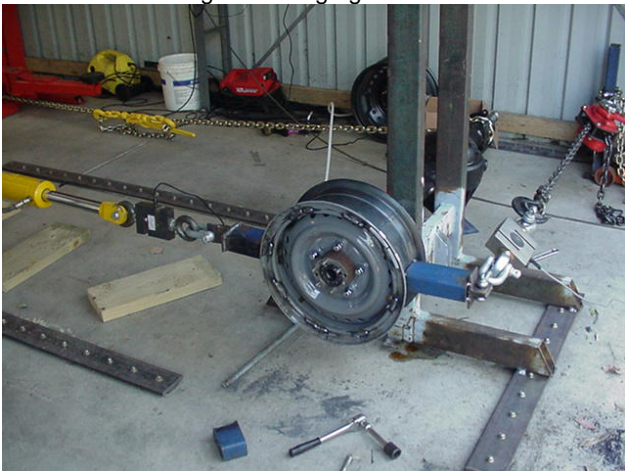
Test rig simulating 1g vertical, load and +0.6g lateral rut load

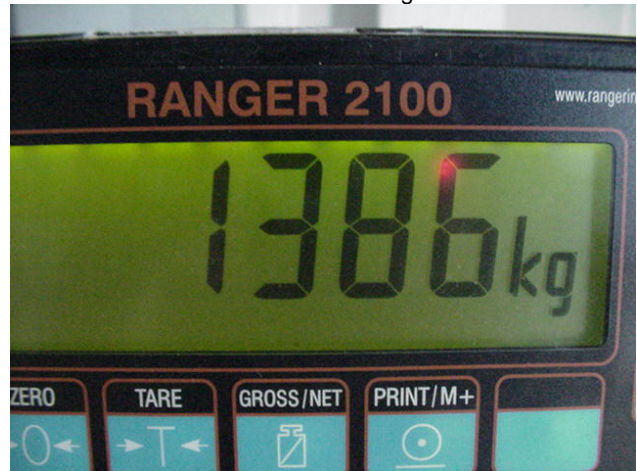
Load cell reading 1g vertical load

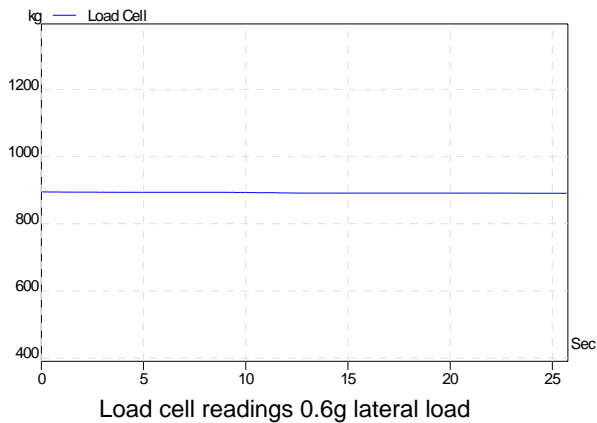
Load cell readings 0.6g lateral load

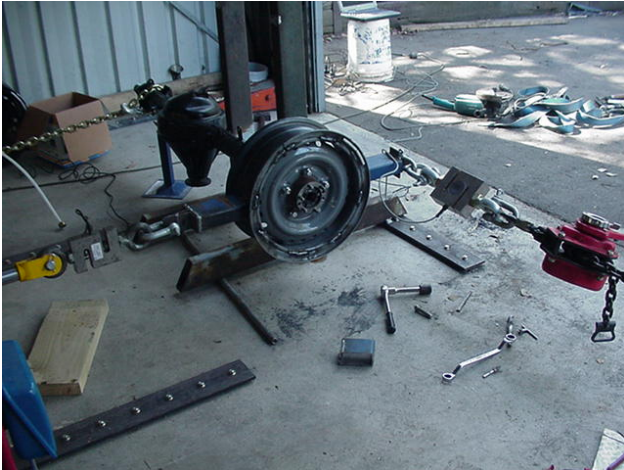
Test rig simulating 1g vertical, load and -0.6g lateral rut load

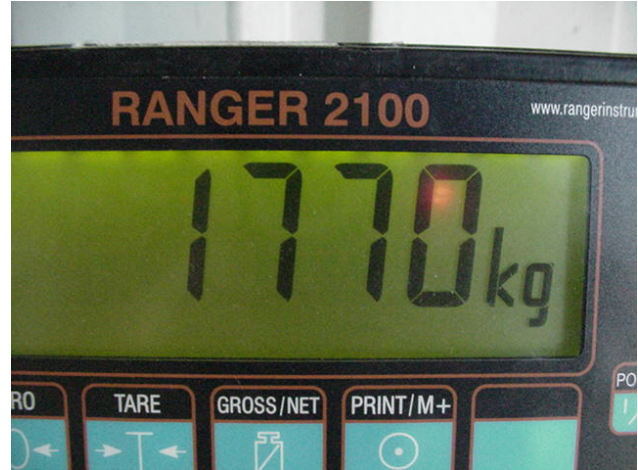
Load cell reading 1 g vertical load

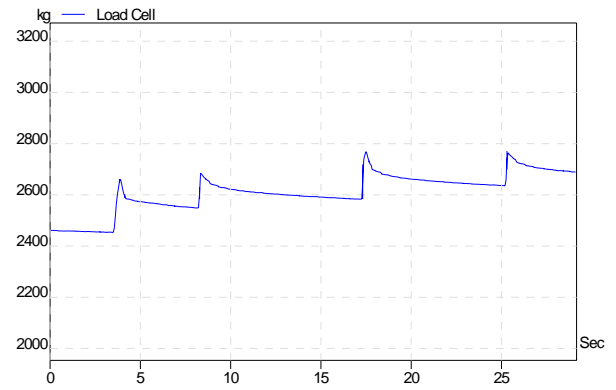
Load cell readings – overturning load applied at point representing tyre to road contact point.

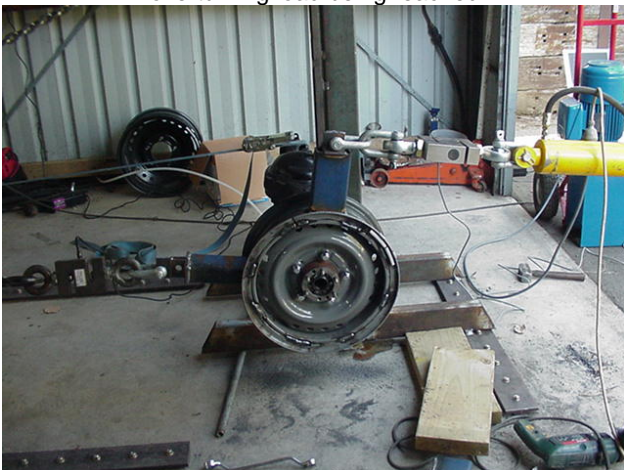
Test rig simulating 2g vertical load and 1.2g braking load. Note that disc calliper and rotor assembly was pinned through the centre of the calliper piston to prevent rotation of the hub and brake disc assembly. This test also tests the strength of the calliper mounting bracket.

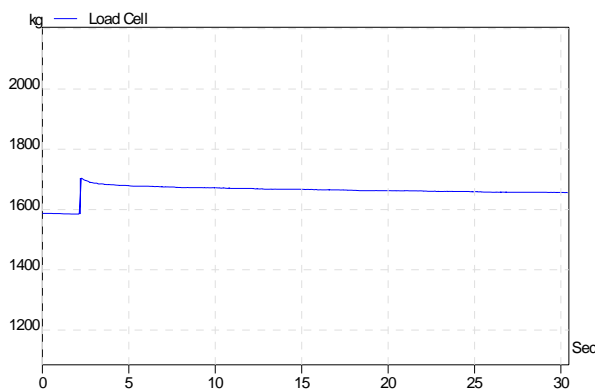
Load cell readings – braking load
